**Attachment N -
District 5 Expressway Area HQ
Maintenance Yard**

**VDOT M54 (General Permit No. VAR04}
Expressway Area Headquarters
VDOT District No. 5**

Facility Name: Expressway Area Headquarters

Date of Visit: October 24, 2012

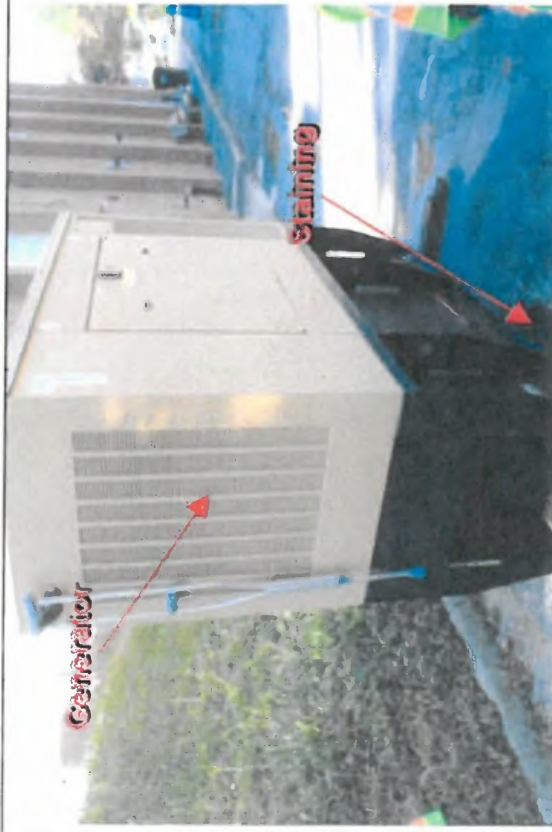
3. Staining was present on the impervious ground surface adjacent to a generator in the southeastern portion of the Facility (see Photographs 1 and 2). The VDOT Foreman/Supervisor II stated that the generator had been brought over from a nearby facility and was not in service. He explained that the generator would likely be connected to the power supply at the Facility within the next couple of months.

Photograph 1 – View of generator in southeastern portion of the Facility.

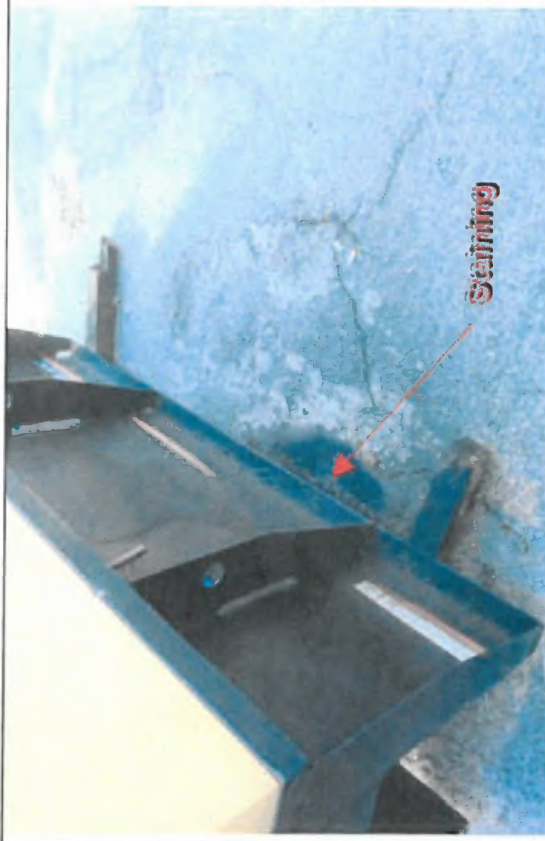
Photograph 2 – View of staining on impervious ground surface adjacent to generator shown in Photo 1.

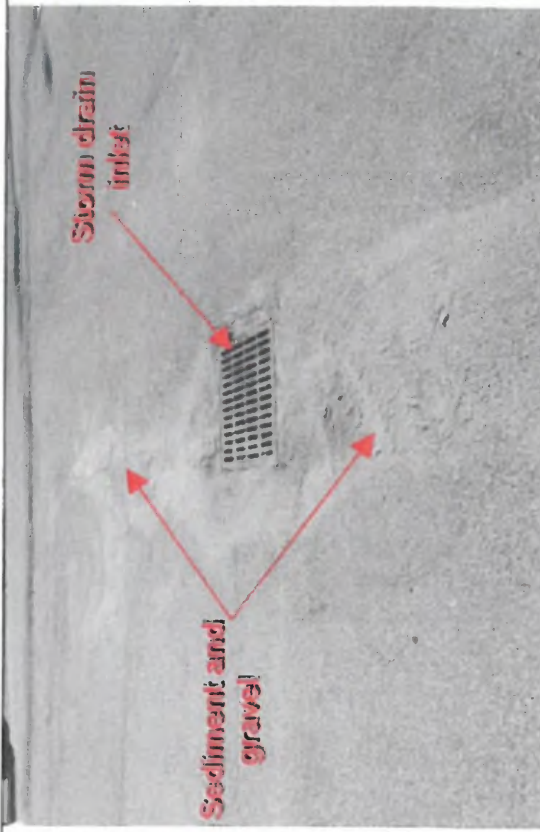
4. Sediment and gravel was observed on the impervious ground surface upgradient and adjacent to a storm drain drop inlet directly in front of the storage building near the center of the Facility (see Photograph 3). BMPs for inlet protection had not been implemented for the storm drain inlet. The VDOT Foreman/Superintendent II (Mr. Allgood) explained that the storm drain inlet had a diversion pipe within it that could be opened to direct salt-laden water that enters the inlet, to underground storage tanks, therefore prohibiting flow to the drainage ditch (see Photograph 4). He explained that about four years prior, the adjacent storage building was used for salt storage and the diversion pipe in the storm drain inlet would have been used during salt loading and unloading operations. He stated that since there is no longer salt storage at the Facility the diversion pipe is left closed so that water would discharge to the drainage ditch and off site.

Photograph 3 – View of storm drain inlet in front of storage building near center of Facility. Note accumulated sediment and gravel and lack of BMPs for inlet protection.

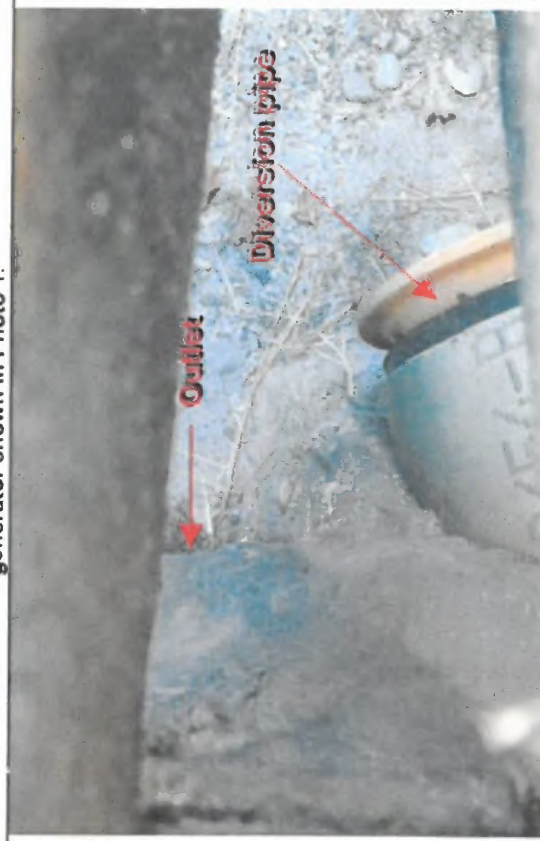
Photograph 4 – View inside storm drain inlet shown in Photo 3. Note that diversion pipe was closed so that flow would exit the drainage ditch rather than discharging to the underground holding tank.

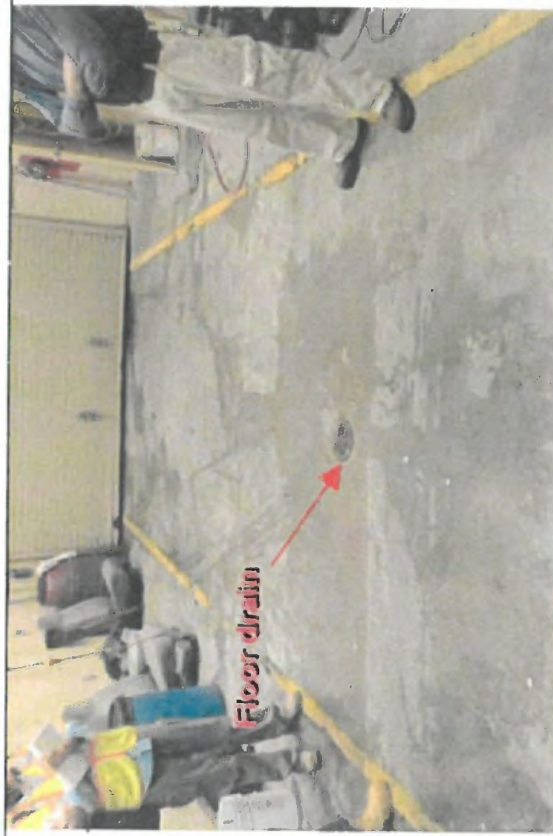
5. A bay inside the "shop" storage building along the western side of the Facility was used for vehicle and equipment washing (see Photograph 5). The VDOT Foreman/Superintendent II stated that the floor drain in the wash bay was connected to an underground storage tank which discharges to the sanitary sewer. The EPA Inspection Team did not view drainage schematics for the Facility to confirm this discharge location. The VDOT Foreman/Superintendent II explained that there are no drainage schematics available for the facility. He also explained that prior to two or three months before the EPA Inspection Team's site visit, state police troopers used to come to the Facility and wash their cars outside of the storage building and wash water would enter a nearby storm drain inlet. He explained that about two to three months prior to the site visit, a consultant to VDOT advised that the Facility no longer allow this practice and that all vehicle and equipment washing occur inside the wash bay.

Photograph 5 – View of vehicle wash bay inside the “shop” storage building.

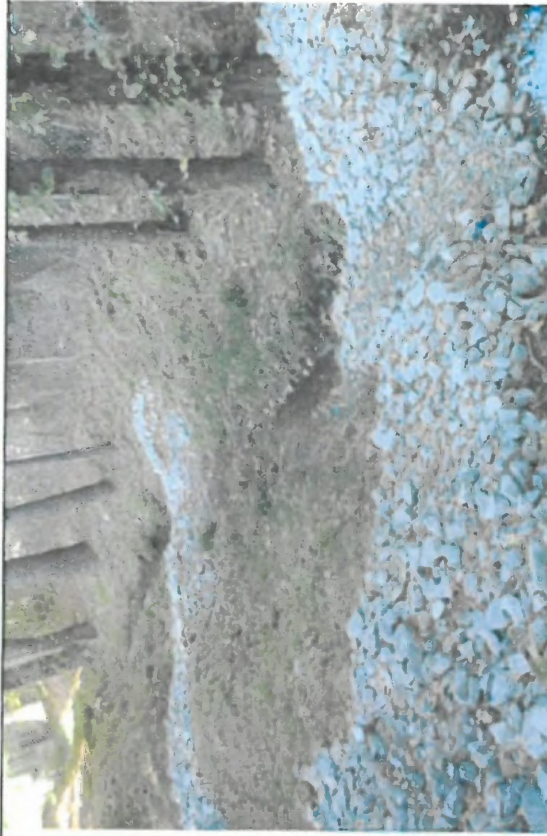
6. Rock check dams were present in the drainage ditch along the northern perimeter of the Facility (see Photograph 6). The VDOT Foreman/Superintendent II explained that the check dams had been installed approximately one month prior to the date of EPA's inspection, in response to recommendations from a consultant to VDOT.

Photograph 6 – View of rock check dams in drainage ditch along northern perimeter of the Facility.
